Case Vehicle (A): 1998 Dodge Type: Caravan, 4-door van

Vehicle (B): 1990 Nissan Type: Pickup, 4x2 regular cab Driver: 53-year-old male

SITUATION

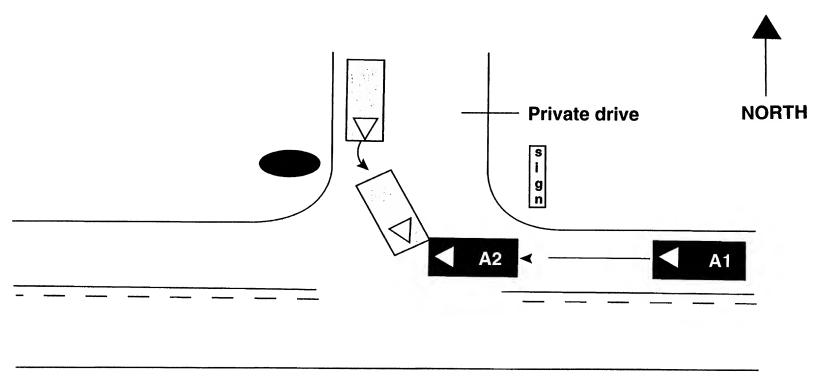
(Slides 1, 2) On a cloudy, dry day, case vehicle (A) was traveling west at a driver-estimated speed of 45 mph (72 kph) in the westbound lane of a two-lane asphalt road, in a rural area. Vehicle (B) was stopped facing south in a private drive that intersects with the two-lane road. As case vehicle (A) approached the private drive, vehicle (B) moved out into the intersecting westbound lane and began to make a left turn to travel east. The driver of case vehicle (A) was unable to avoid being struck in the right front by the left front of vehicle (B).

speed limit 45 mph (72 kph)

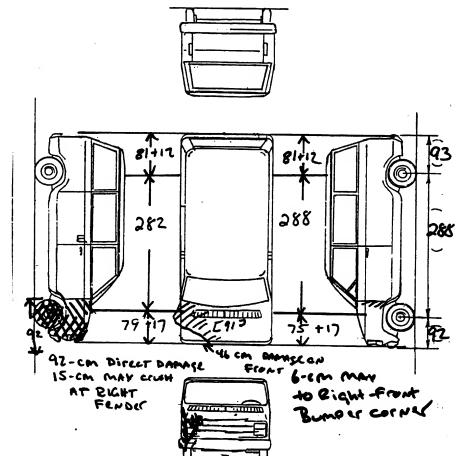
(Slide 3) The direct damage to case vehicle (A) began at the right-front bumper corner and extended 46 cm across the front bumper, resulting in a 32 percent vehicle overlap. The damage also extended 92 cm rearward along the right fender, with a maximum crush of 15 cm. (Slide 4) The maximum crush to the right-front bumper corner was 6 cm.
